I have worked on both front gear cases of my 1996 L3600 (same as L3710). There are four seals at each wheel where leaks can develop - two are moving lip seals (**A**, **B**) and two are static seals (**C**, **D**)

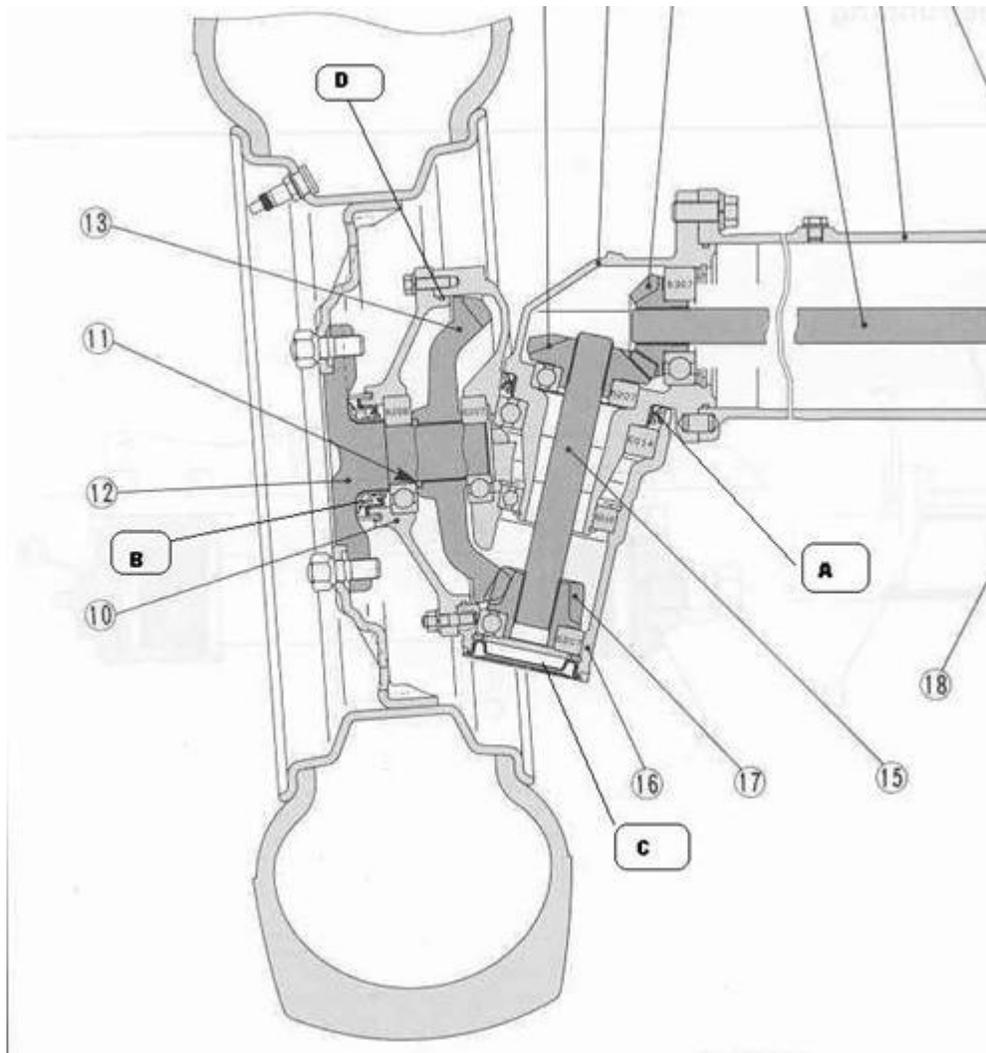
A good way to be sure where your leak is coming from is to clean everything up with the wheels off and see where the drips re-appear. With luck it's just the bottom cap **C** or the o-ring **D** weeping a bit.

But the **A** seal is known to be a weak point on these axles. It can let oil out - or worse it can let water in - leading to failure of the bearings. [kubota](#) has redesigned the seal - so hopefully the new one is better. On my rig I replaced the **A** seals and the **C** caps on both sides. One side also needed bearings.
