<b>PSB-2005-052-A</b>	<b>Date: 19 December, 2005</b>
<b>Title</b>	<b>L2800HST &amp; L3400HST; PTO Cams</b>
<b>Group Code</b>	<b>PT06</b>
<b>Product Line</b>	<b>L-Series</b>
<b>Model Number (s)</b>	<b>L2800HST, L3400HST</b>

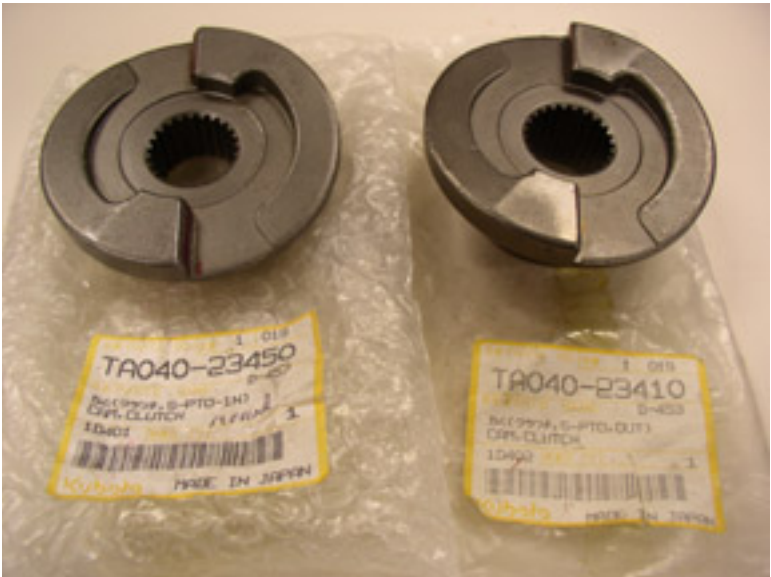
On HST MODELS, a "Ratcheting Noise" may be heard during **engine de-acceleration** while the rear PTO is **engaged**.

This noise results from the overrunning action of the PTO clutch cams.

Old Style Clutch Cams (P/N TC220-99980)

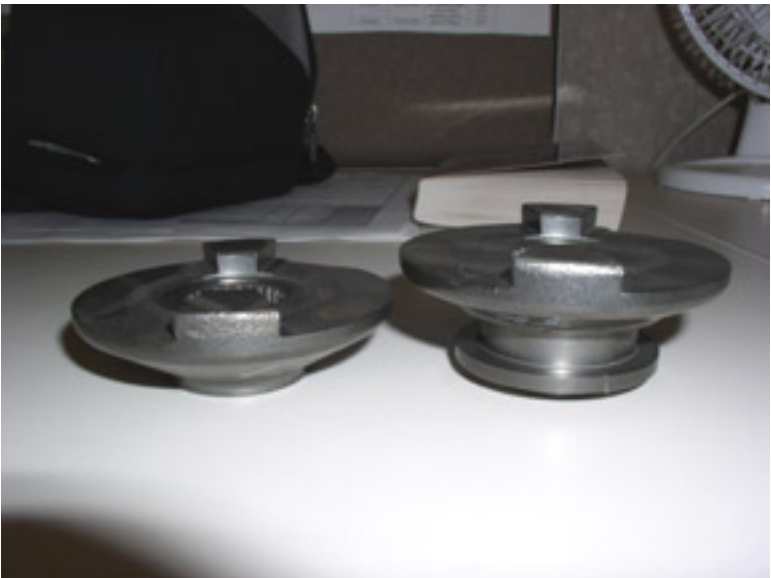
New Style Clutch Cams (P/N TC220-99990)

The old style cams have been replaced with new "solid type" style, engagement cams.

Part Number	Part Name
TC220-99990	Kit, Cam Clutch / PTO
