## PRODUCT SERVICE BULLETIN

### **FIX AS FAIL: B/BX-Series; Oil Leakage From Loader Quick Coupler**

**Product Line:** B/BX-Series

**Model:** BX1880, BX2380, BX2680, BX23S, B2301HSD-1, B2601HSD-1, B2401DT, BX2417, B1677, B1982

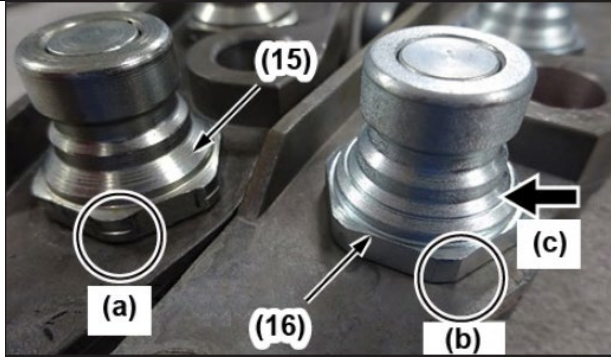
The wholegoods kits affected are not serialized; this issue only applies to wholegood kits containing the old-style couplers. Please see the below image for examples of the old-style vs. new-style to determine if this bulletin applies.

(15) Old Cartridge  
(16) New Cartridge

(a) Notch in Hex.  
(b) No Notch in Hex.  
(c) Groove on surface
