PSB-2008-028-B	Date: February 20, 2009
Title	SERVICE ACTION; ZD326 & ZD331, Ground Wire Relocation
Group Code	EL05 – Wiring Harness
Product Line	Z - Tractor
Model Number (s)	ZD326S/P & ZD331P/LP

SERVICE ACTION

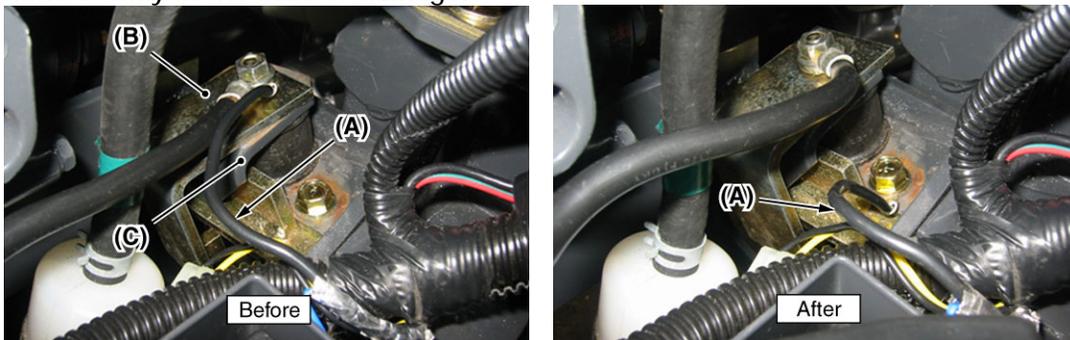
Kubota has determined that there may be poor or inadequate contact between the harness ground wire and the negative battery cable at the engine mount isolator (see "Before" photo below). This may result in poor or insufficient starting performance.

Please relocate the harness ground wire eye directly to the frame as per the instructions of this bulletin (see "After" photo below). Check/clean all ground contact points to ensure adequate grounding. Replace wire harness only in the case of damage.
