PSB-2005-052-A	Date: 19 December, 2005
Title	L2800HST & L3400HST; PTO Cams
Group Code	PT06
Product Line	L-Series
Model Number (s)	L2800HST, L3400HST

SUBJECT:

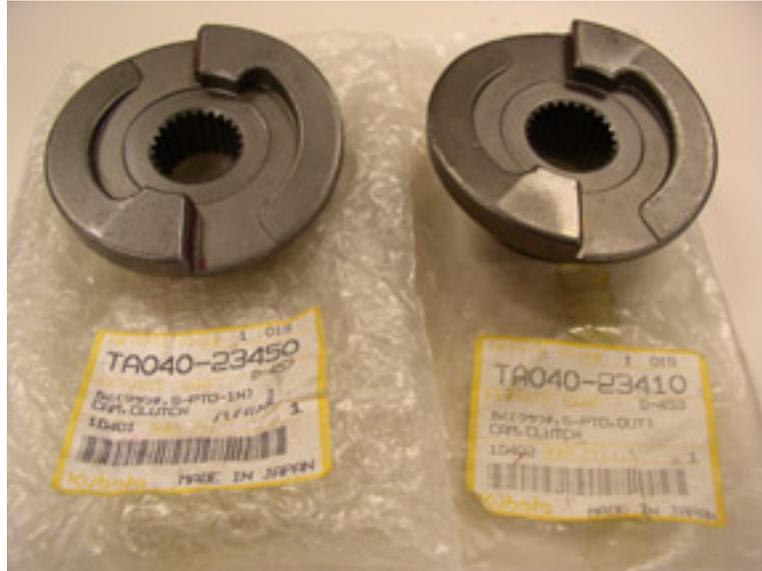
On HST MODELS, a "Ratcheting Noise" may be heard during **engine de-acceleration** while the rear PTO is **engaged**.

This noise results from the overrunning action of the PTO clutch cams.

Old Style Clutch Cams (P/N TC220-99980)

The old style cams have been replaced with new "solid type" style, engagement cams.

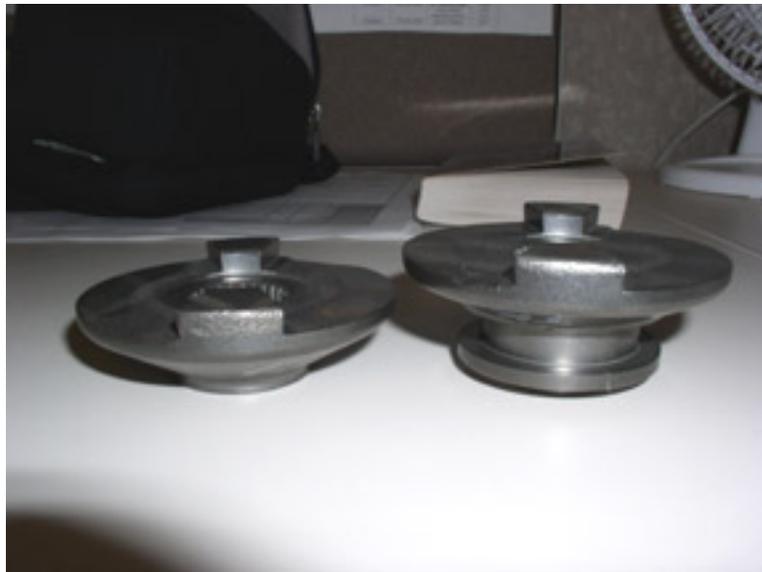
New Style Clutch Cams (P/N TC220-99990)

Part Number	Part Name
TC220-99990	Kit, Cam Clutch / PTO
