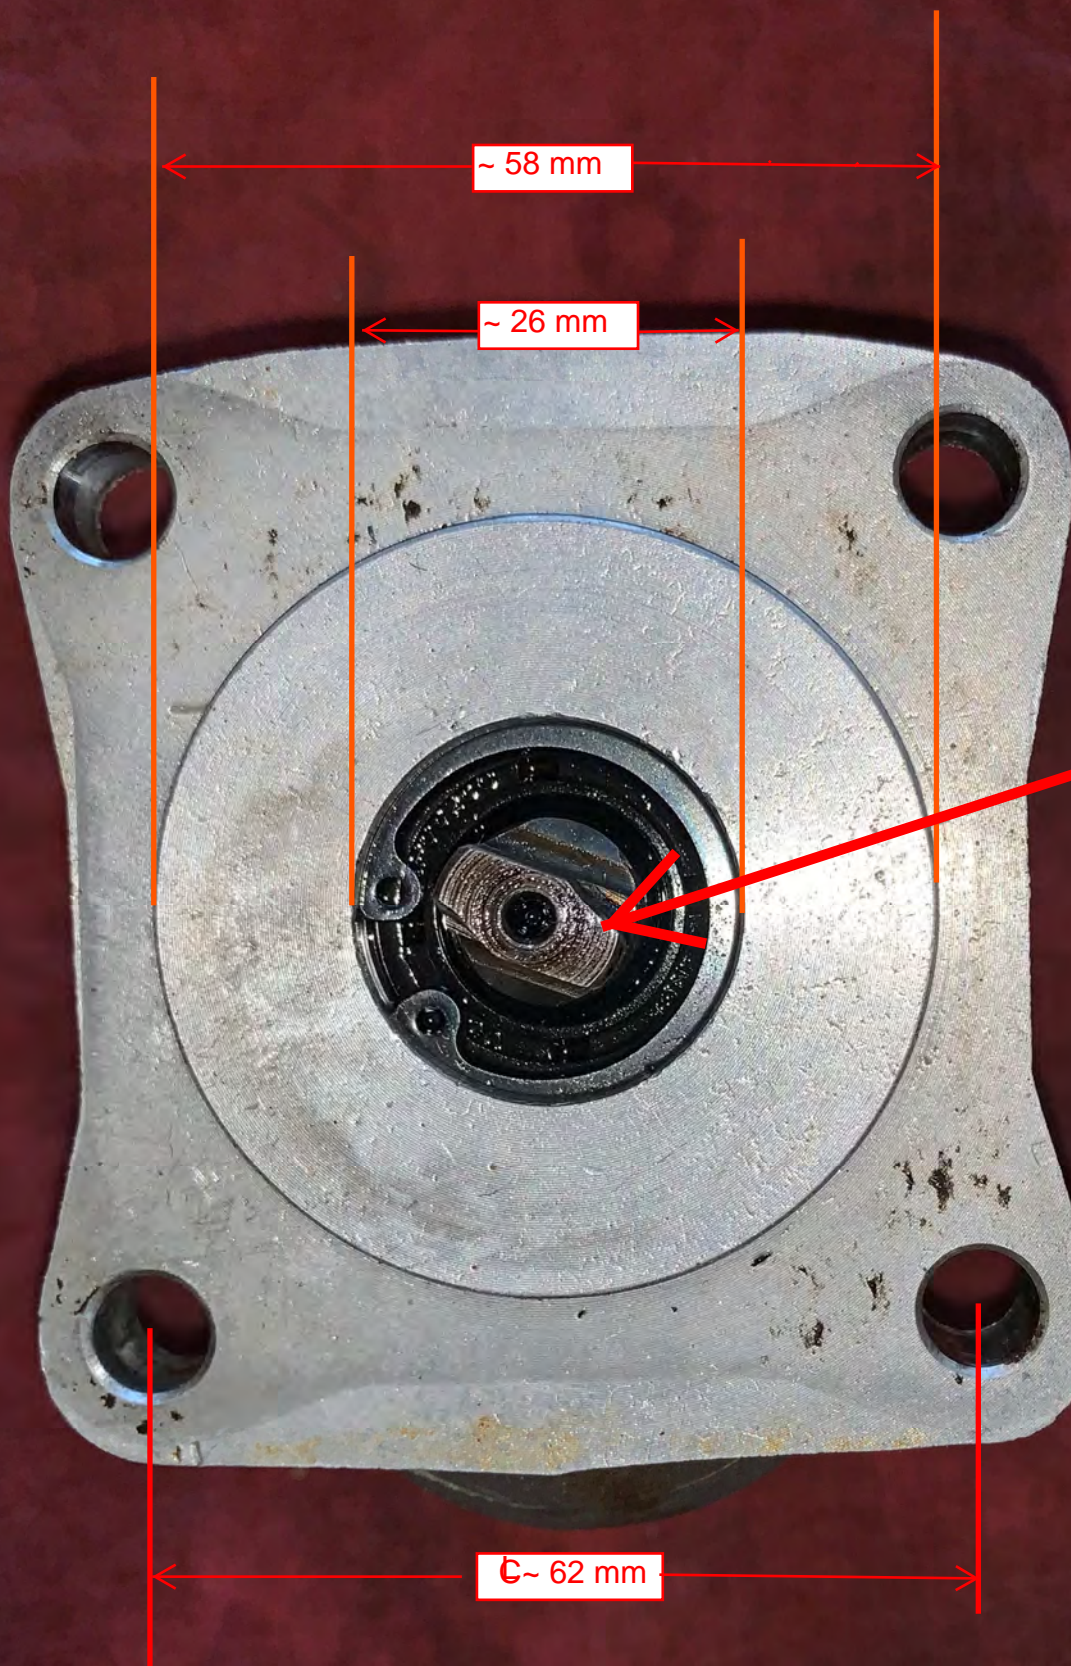
Hydraulic Pump  
(Surface that  
Interfaces with the  
Engine Block.)  
I am calling this a  
gear. If you look  
closely you will note  
that it is not  
rectangular. It looks  
as though the pump  
froze at some point.  
This "gear" fits into a  
drive gear in the  
motor. It Caused  
dammage to that  
drive gear also.

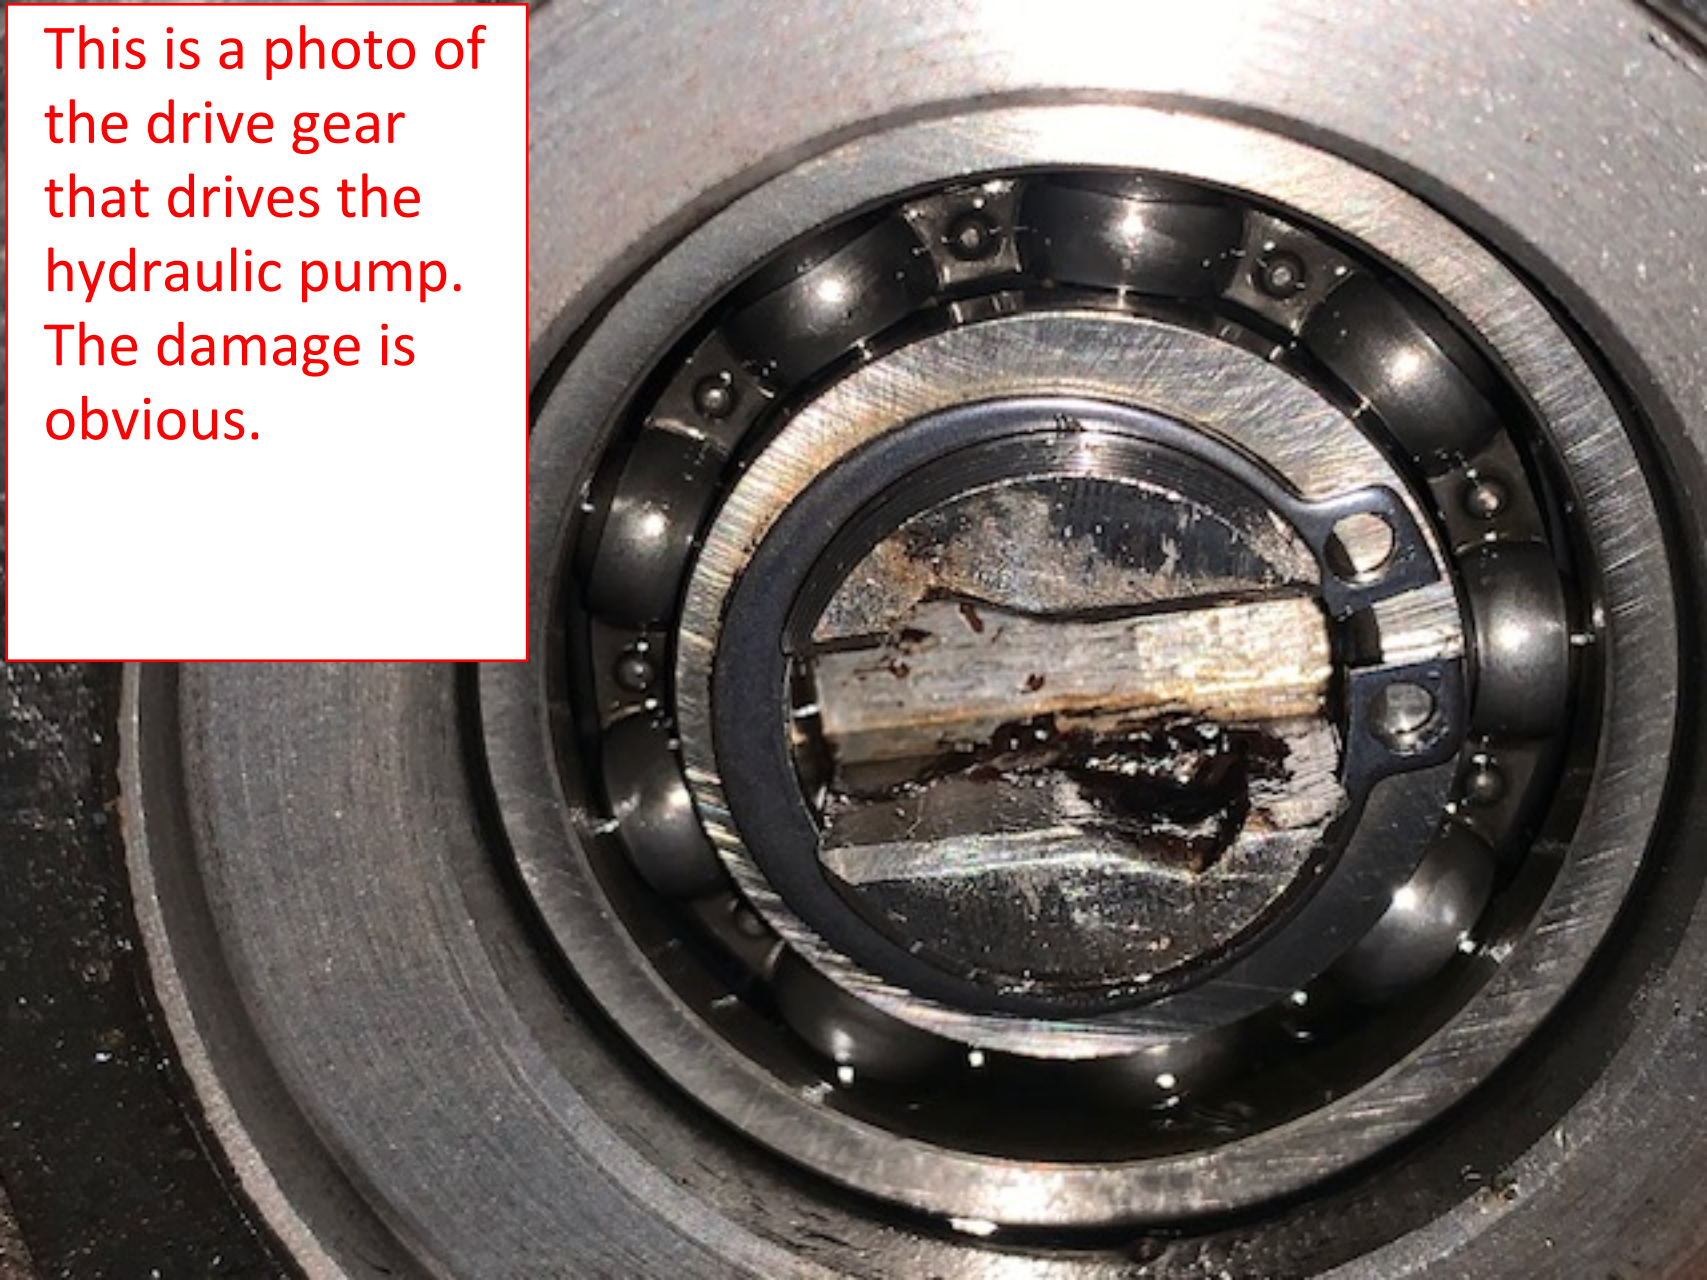
This is a photo of the drive gear that drives the hydraulic pump. The damage is obvious.
